Gold King Mine

Silverton, San Juan County, Colorado

0001/1408-01

## PHOTOGRAPH LOG

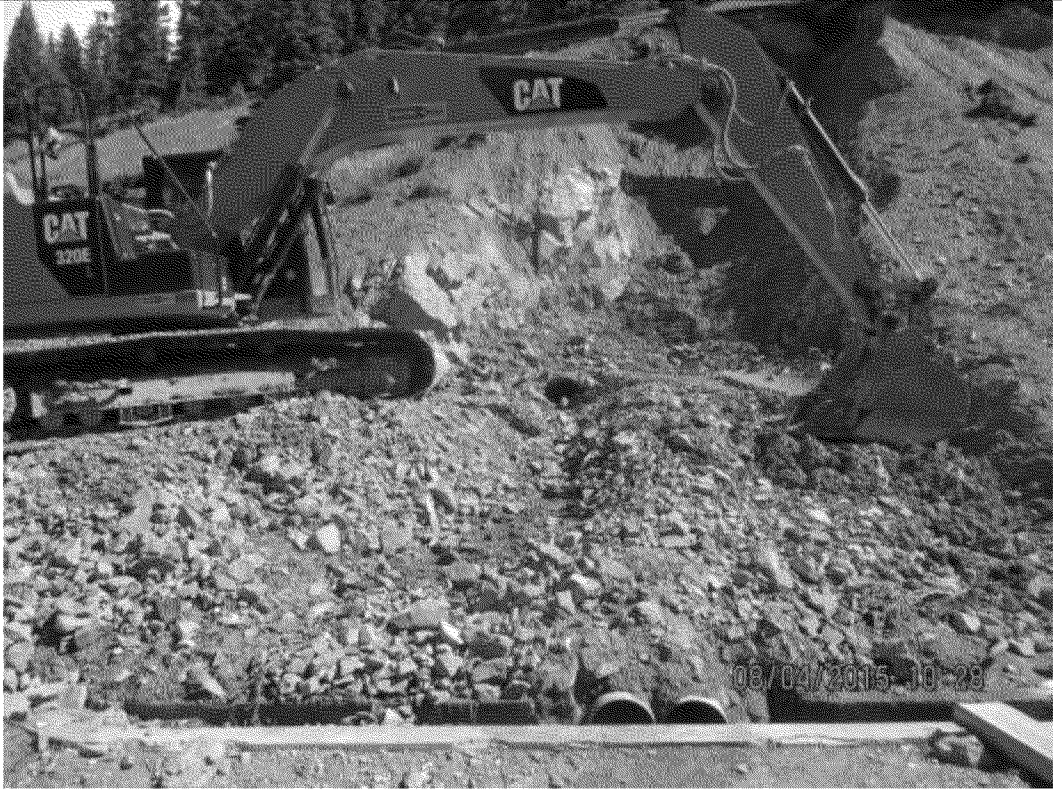
<p><b>Photo No.</b> <b>1</b></p>	<p><b>Date:</b> 08/04/2015</p>

<p><b>Direction Photo Taken:</b></p> <p>North</p>		
<p><b>Description:</b> Beginning investigation into collapsed adit.</p>		
<p><b>Photo No.</b> <b>2</b></p>	<p><b>Date:</b> 08/04/2015</p>

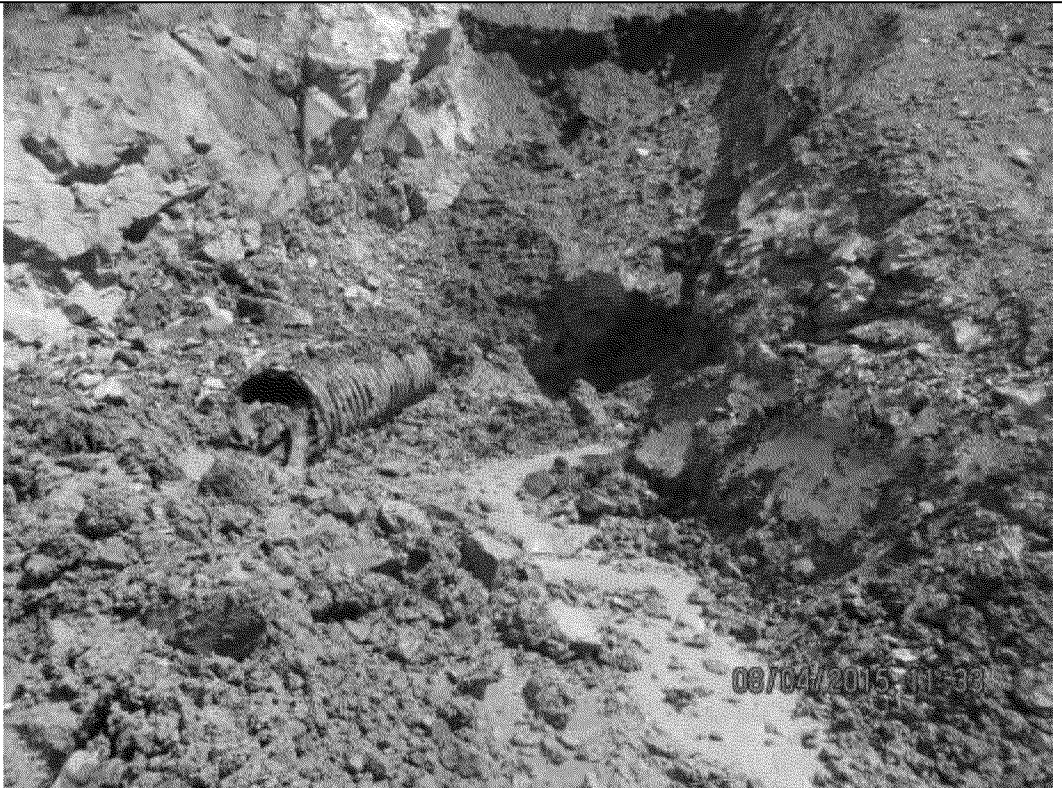
<p><b>Direction Photo Taken:</b></p> <p>North</p>		
<p><b>Description:</b> Excavated next to DRMS-installed culvert, water muddy from soil disturbance.</p>

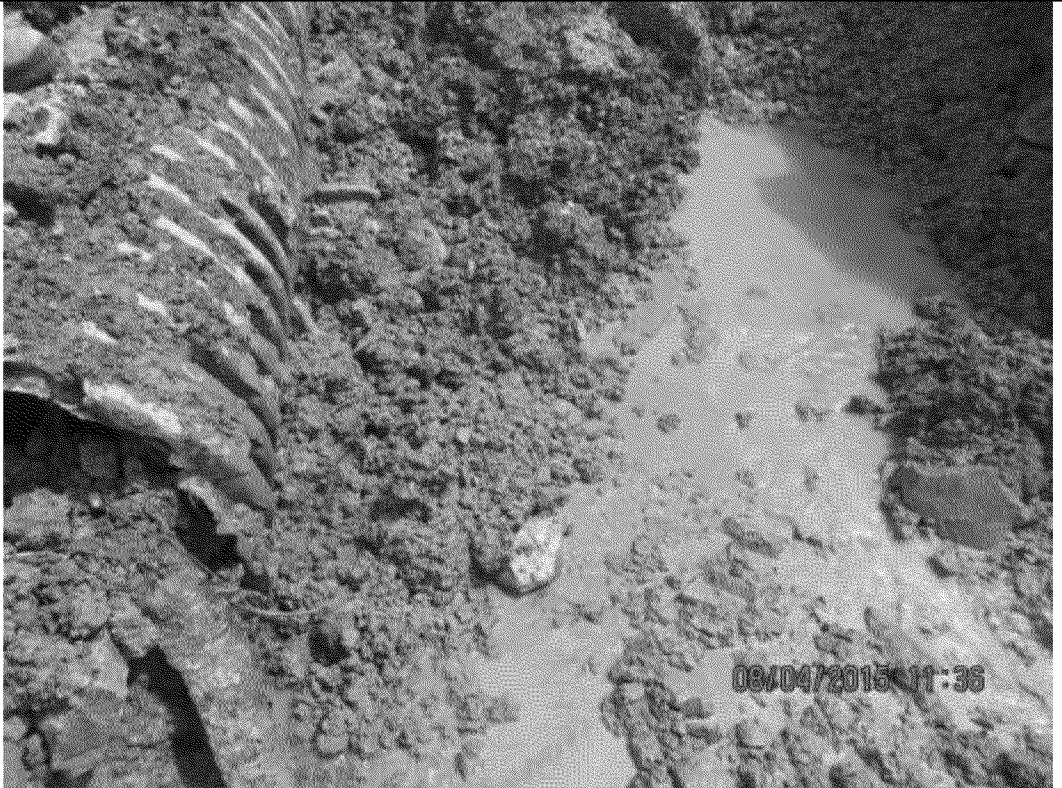
<b>Photo No.</b> 3	<b>Date:</b> 08/04/2015

<b>Direction Photo Taken:</b>  Down		
<b>Description:</b> Seepage from soil next to piping.		
<b>Photo No.</b> 4	<b>Date:</b> 08/04/2015

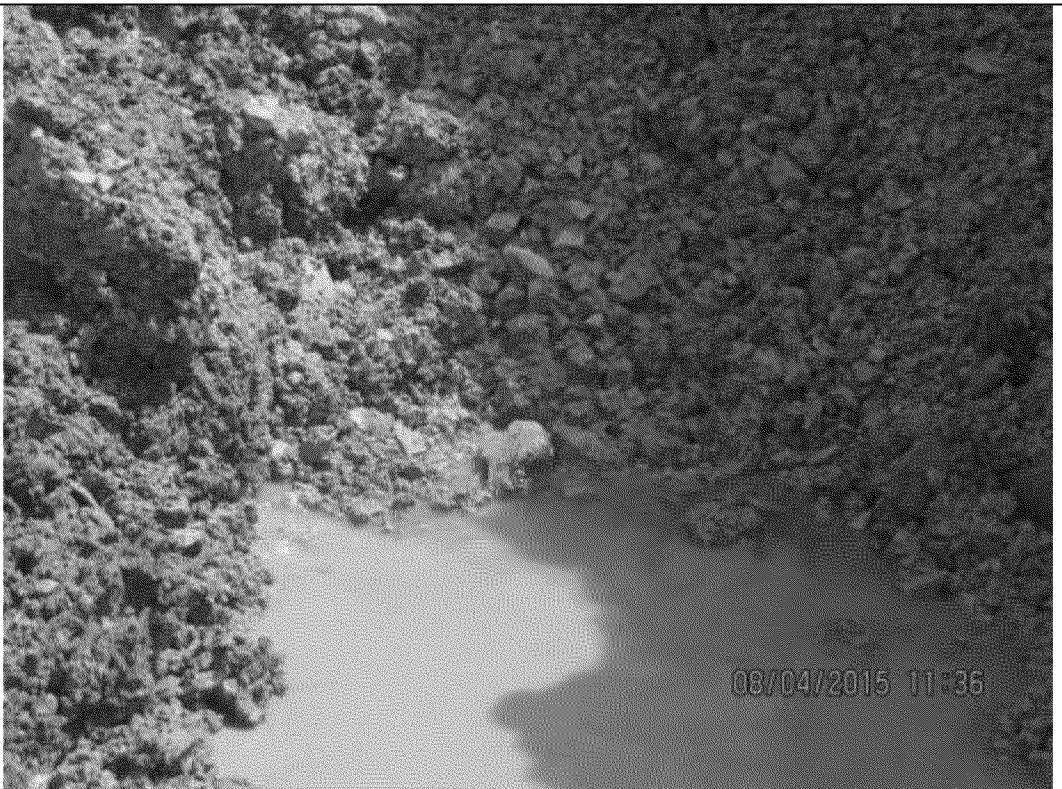
<b>Direction Photo Taken:</b>  Down		
<b>Description:</b> Seepage next to the pipe is clear until entering disturbed soil.

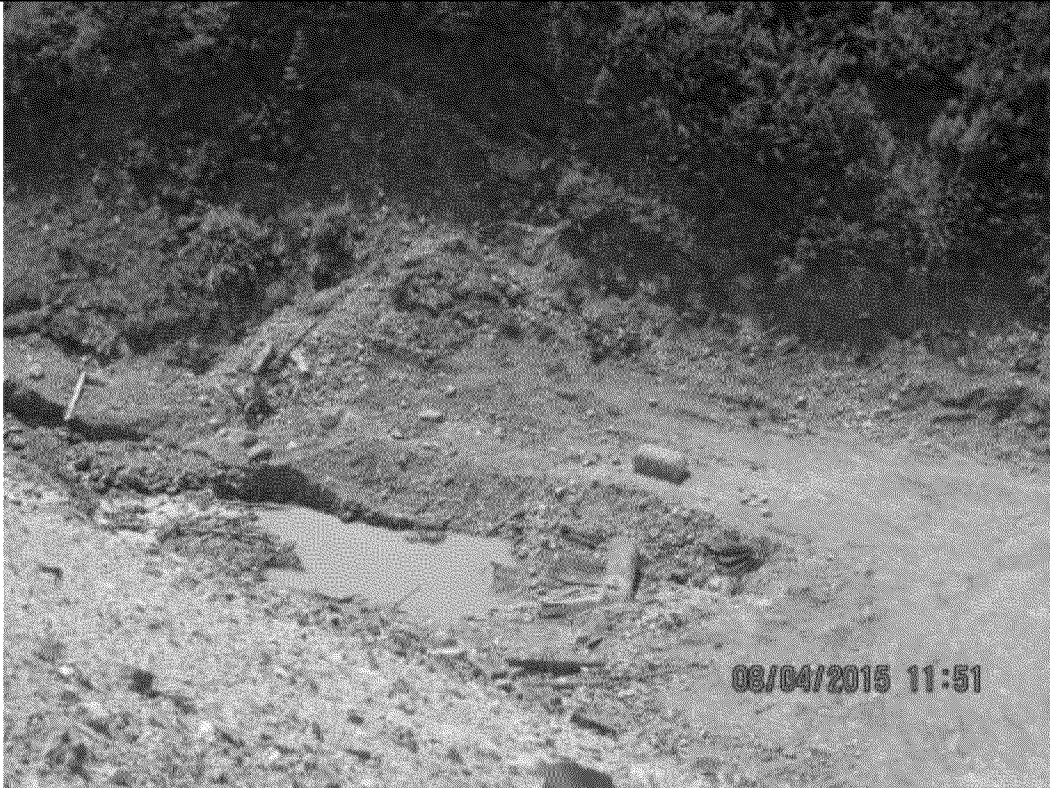
<b>Photo No.</b> 7	<b>Date:</b> 08/04/2015

<b>Direction Photo Taken:</b>  South/Down		
<b>Description:</b> Hay bales installed as filter for sediment in North Fork.		
<b>Photo No.</b> 8	<b>Date:</b> 08/04/2015

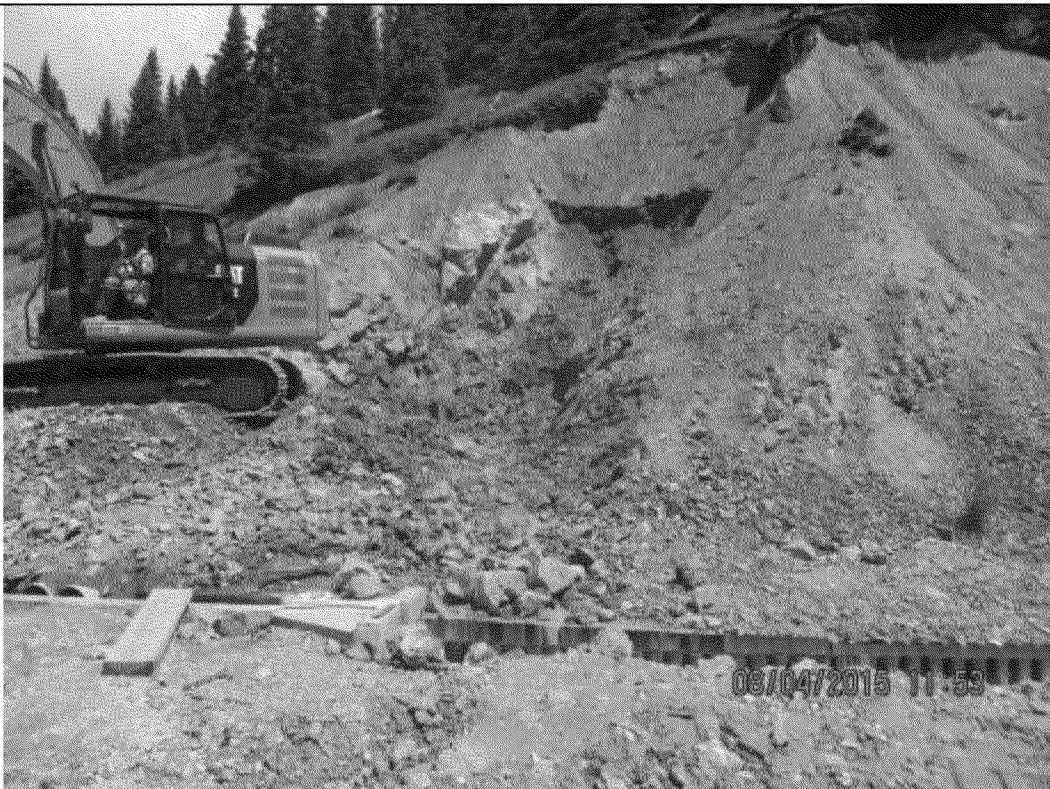
<b>Direction Photo Taken:</b>  Northwest		
<b>Description:</b> Continuing excavation at the collapsed adit, no solid bedrock found for tunnel support.

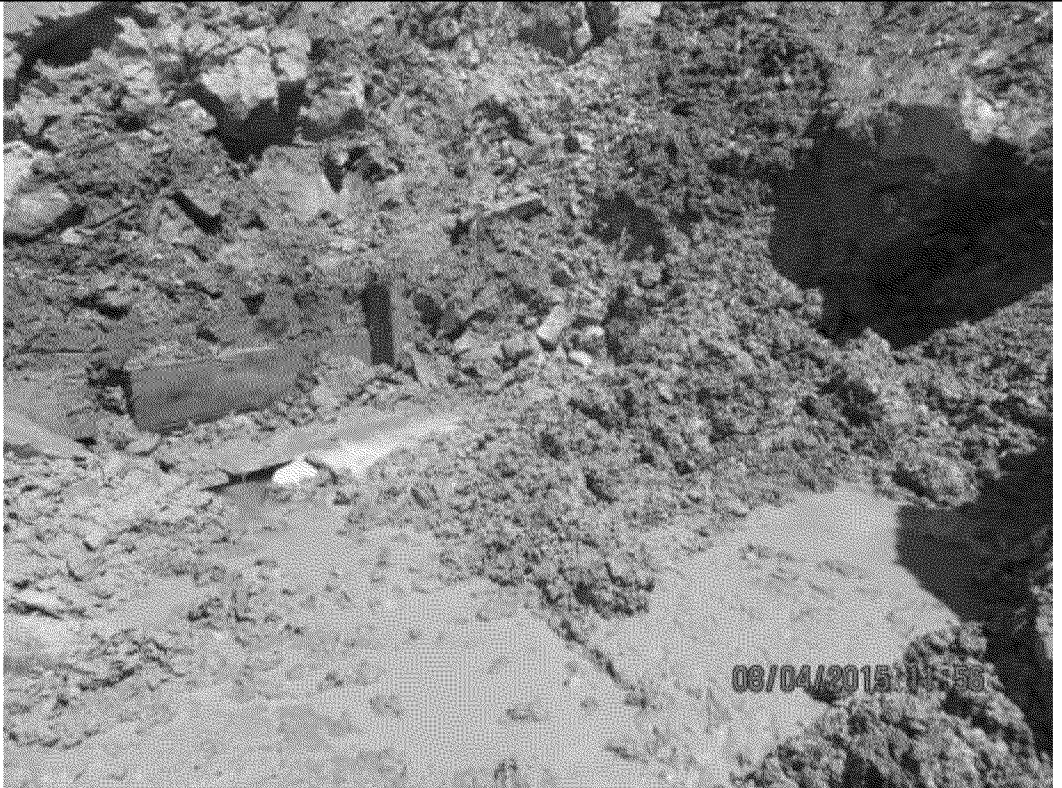
<b>Photo No.</b> 9	<b>Date:</b> 08/04/2015

<b>Direction Photo Taken:</b>  Northeast		
<b>Description:</b> First signs of adit, support pillar with lagging.		
<b>Photo No.</b> 10	<b>Date:</b> 08/04/2015

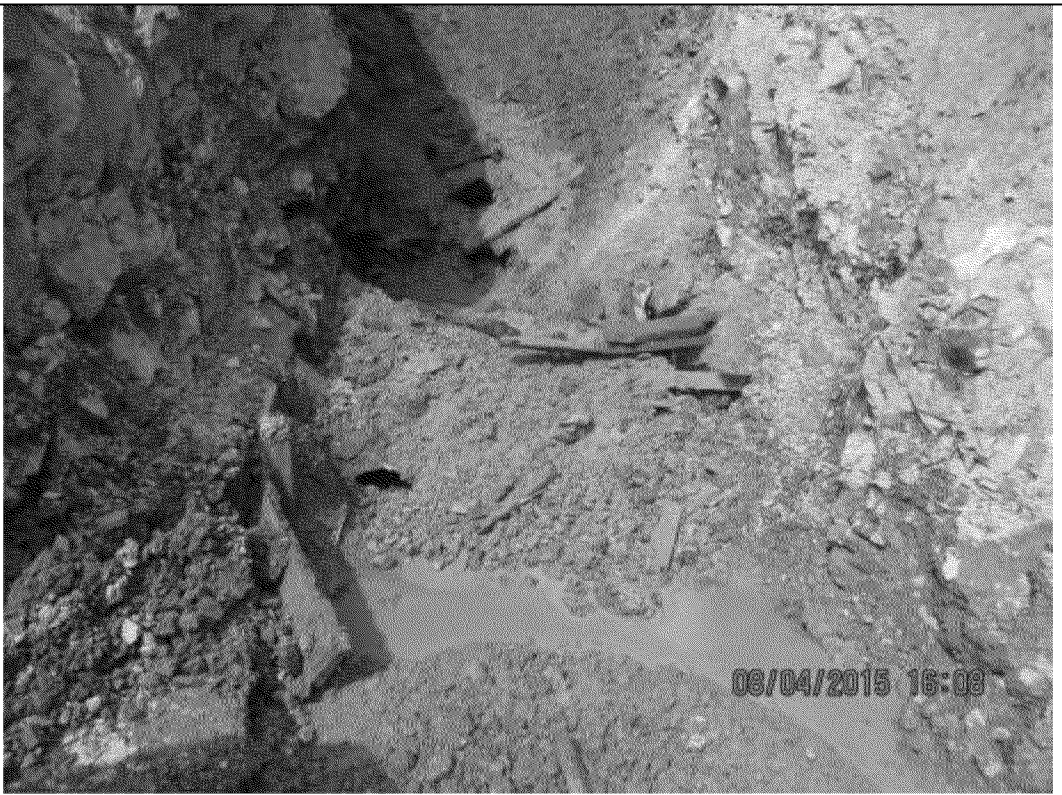
<p><b>Direction Photo Taken:</b></p> <p>North</p>		
<p><b>Description:</b> Collapsed supports uncovered above anticipated adit, no sign of bedrock above the adit area.</p>

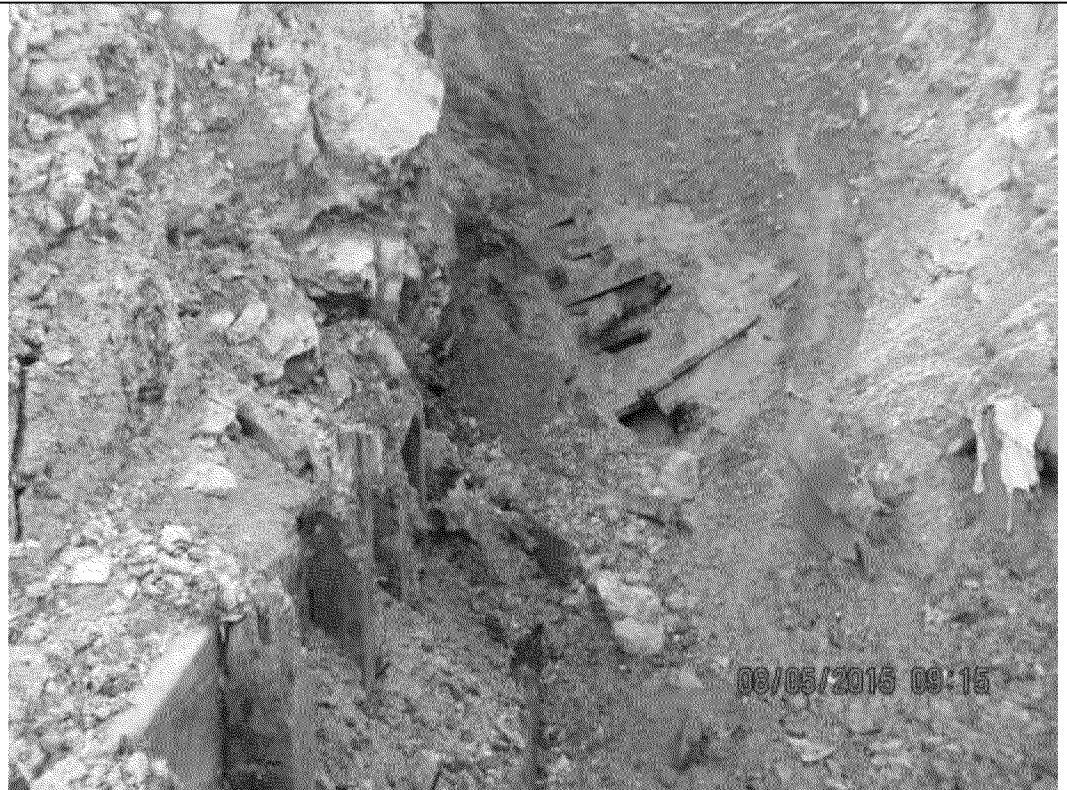
**Photo No.**  
**13**

Adit conditions the morning of 8/5.

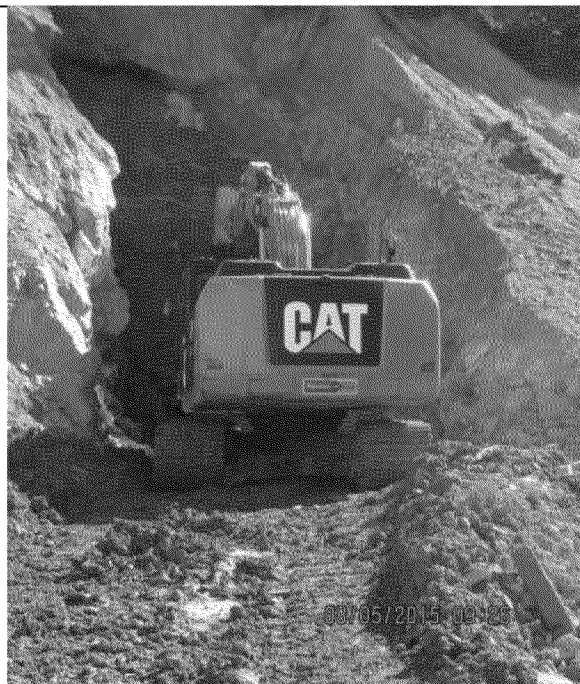
**Photo No.**  
**14**

Excavating material above the collapsed adit.

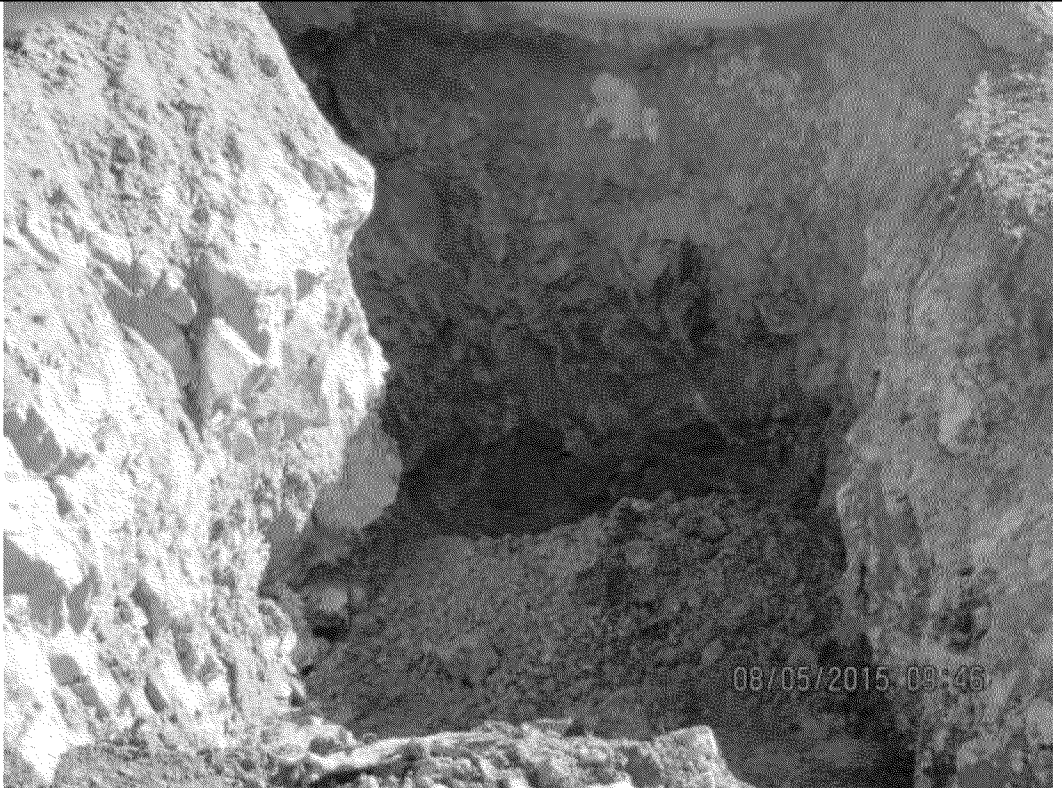
<b>Photo No.</b> 15	<b>Date:</b> 08/05/2015

<b>Direction Photo Taken:</b>  North		
<b>Description:</b> Bedrock found above the anticipated adit.		
<b>Photo No.</b> 16	<b>Date:</b> 08/05/2015

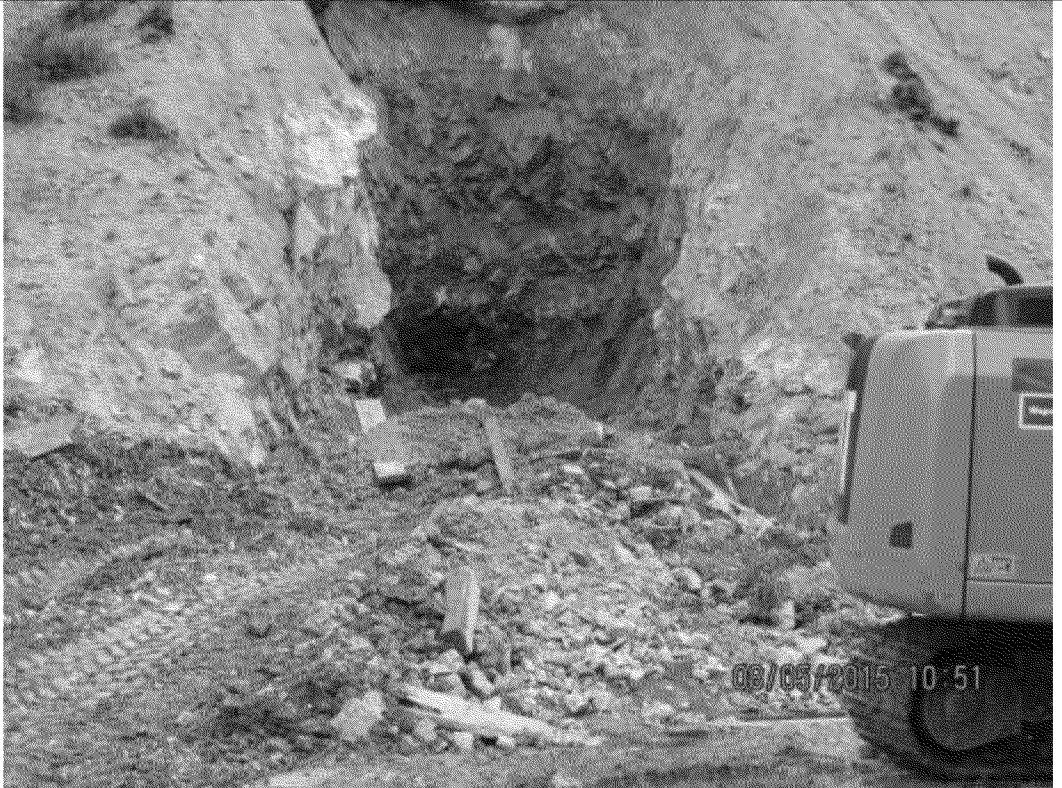
<b>Direction Photo Taken:</b>  North		
<b>Description:</b> Cleaning out excavated material, small leak.

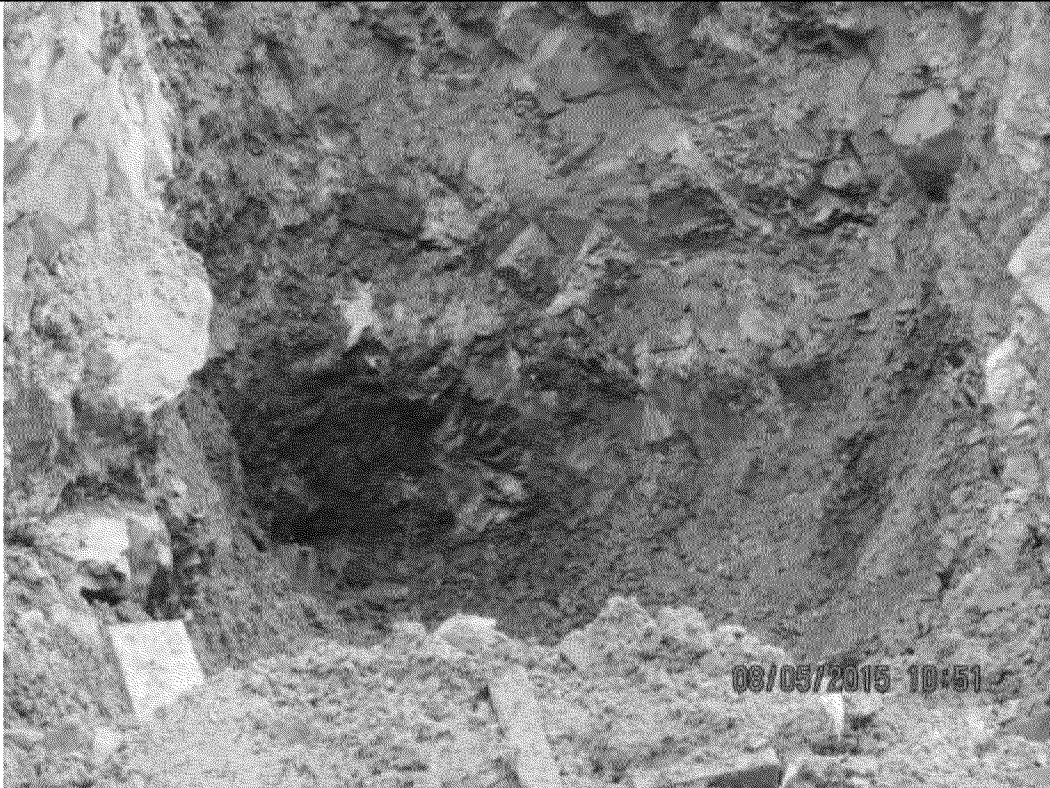
<p><b>Direction Photo Taken:</b></p> <p>North</p>		
<p><b>Description:</b> Small leak close up.</p>		
<p><b>Photo No.</b> <b>18</b></p>	<p><b>Date:</b> 08/05/2015</p>

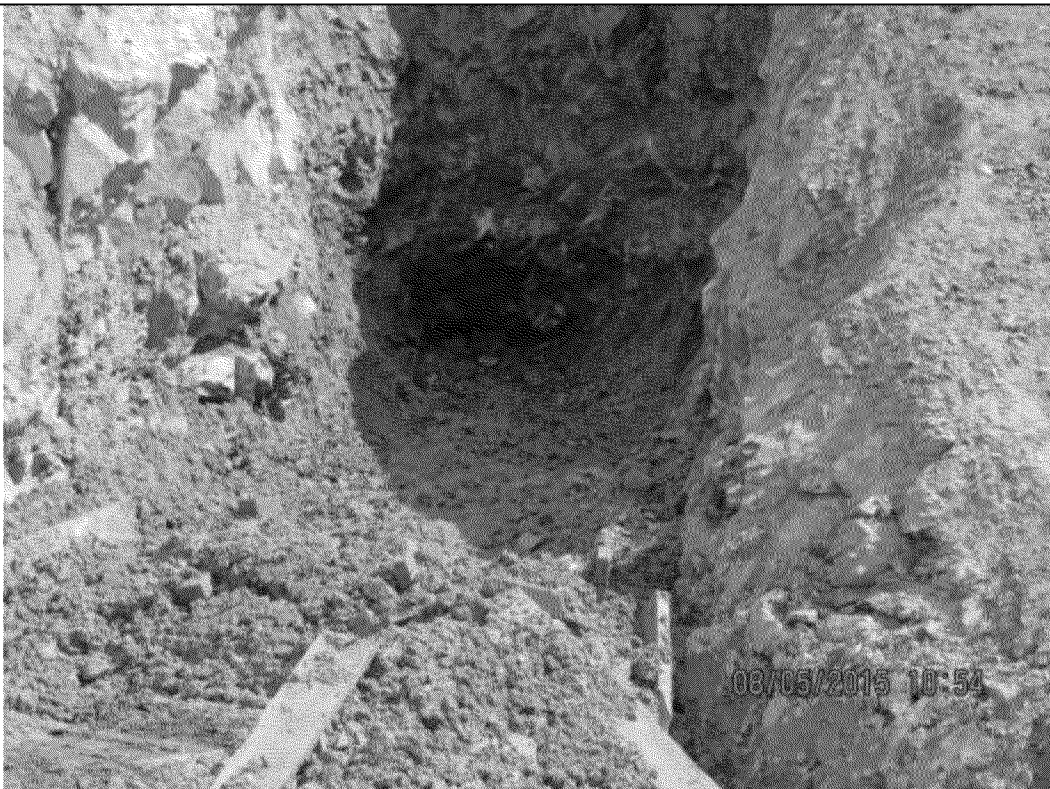
<p><b>Direction Photo Taken:</b></p> <p>North</p>		
<p><b>Description:</b> Hole starting to give way to flow.</p>

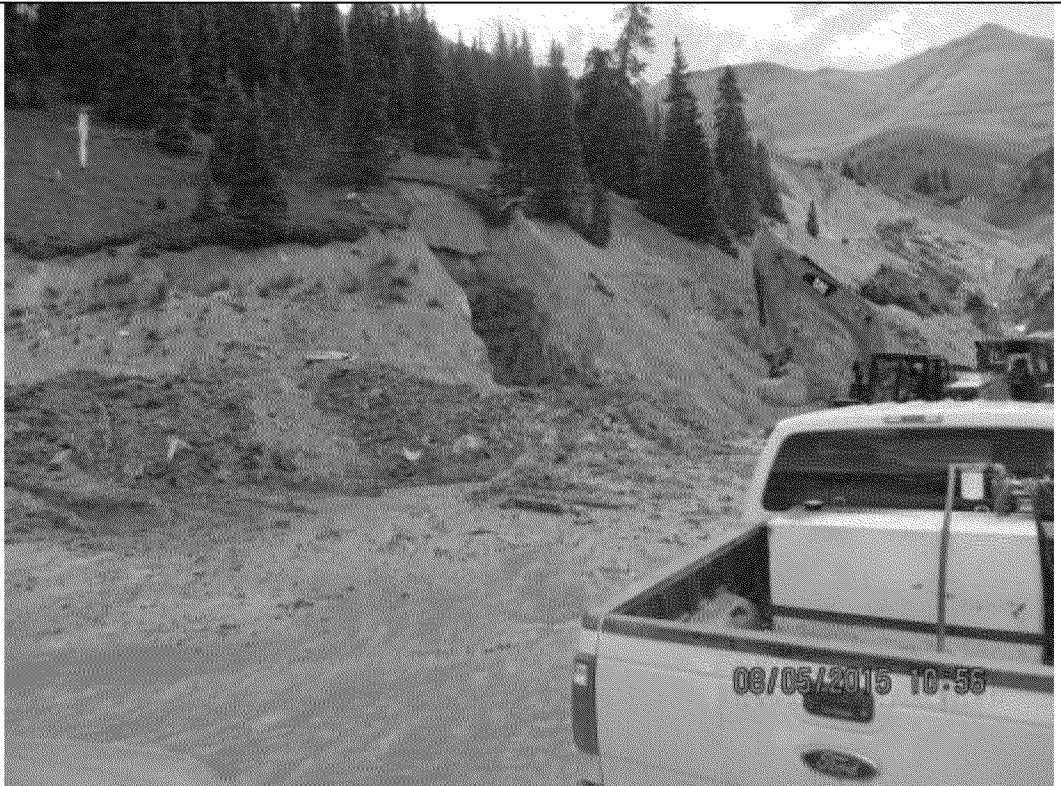
<b>Photo No.</b> <b>19</b>	<b>Date:</b> 08/05/2015

<b>Direction Photo Taken:</b>  Northeast		
<b>Description:</b>  Adit flow increasing.

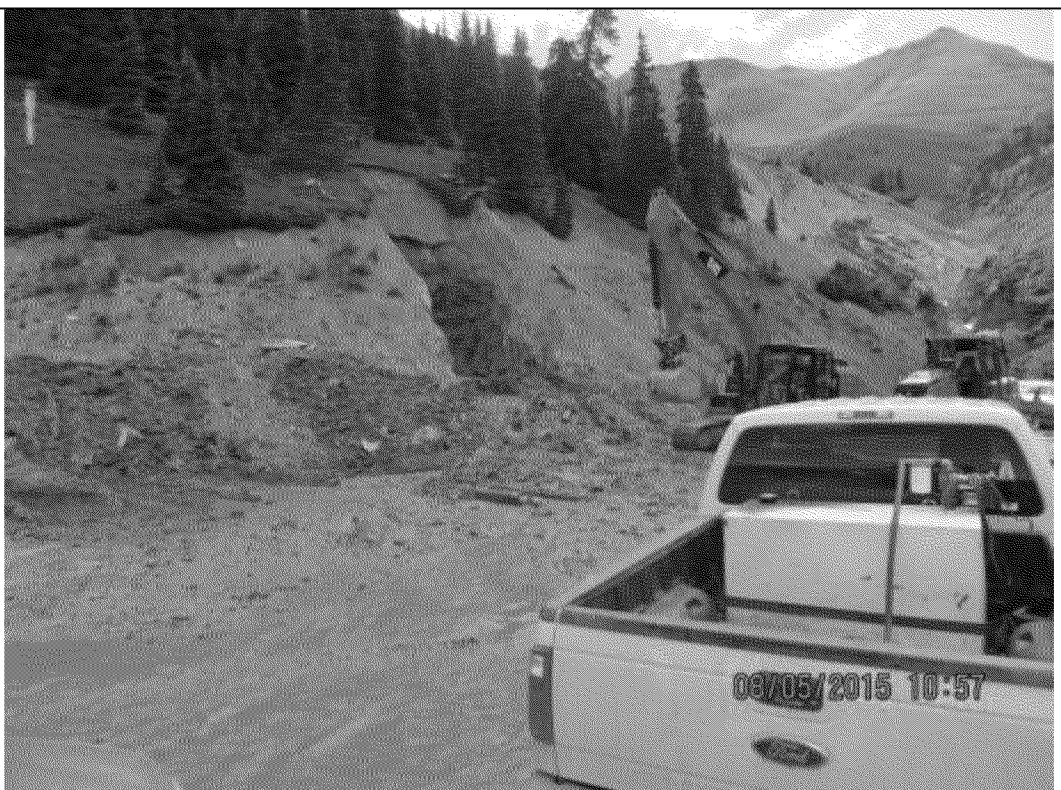
<b>Photo No.</b> <b>20</b>	<b>Date:</b> 08/05/2015

<b>Direction Photo Taken:</b>  Northeast		
<b>Description:</b>  Water flooding out at increased rate.

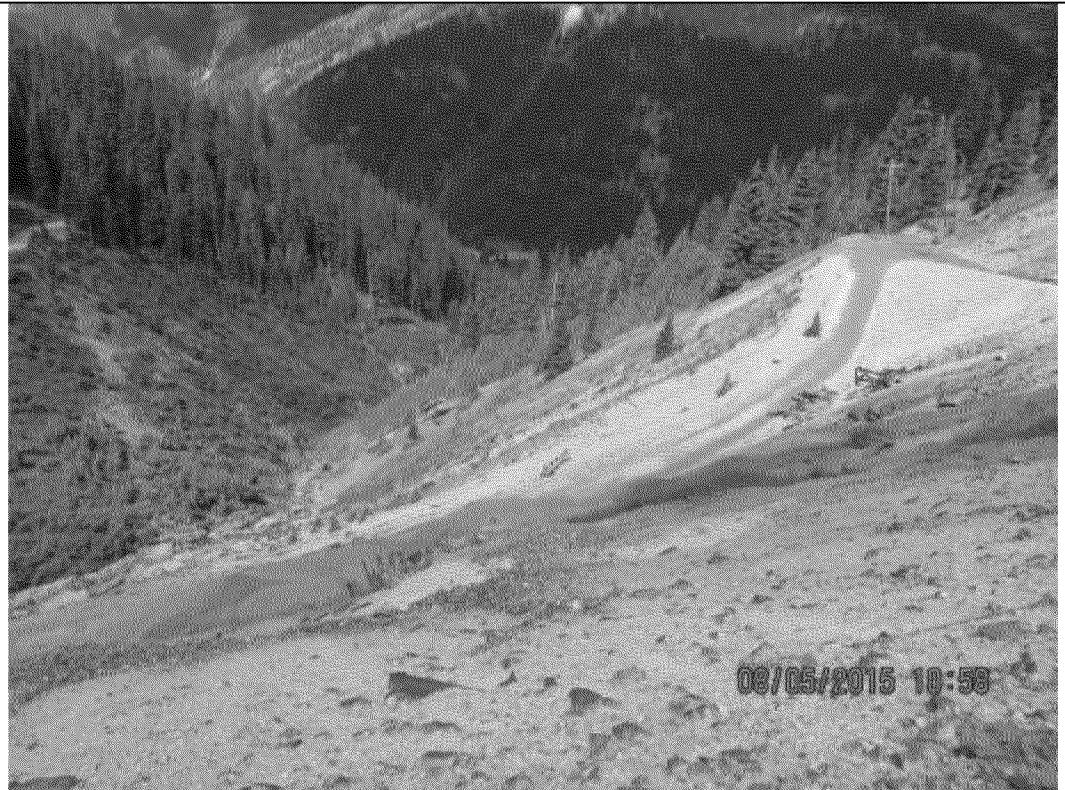
**Photo No.**  
**21**

Water flowing along access road and across waste dump.

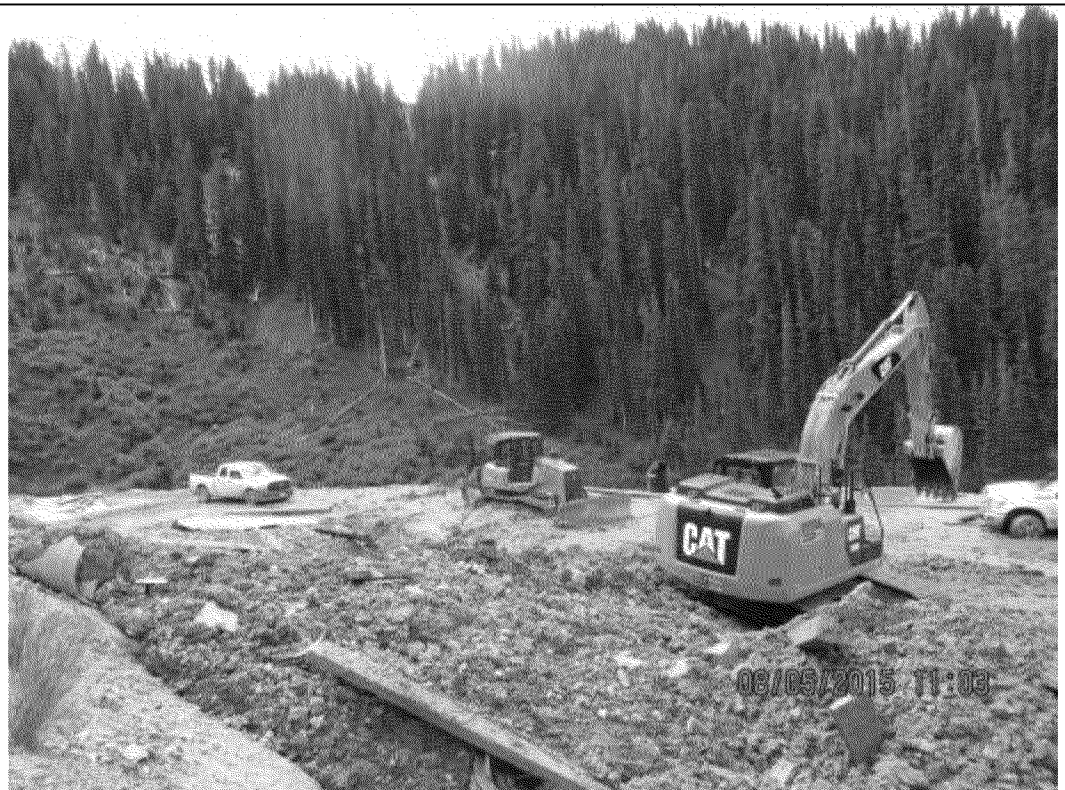
**Photo No.**  
**22**

Water flowing over the edge of the waste dump and collapsing the edge.

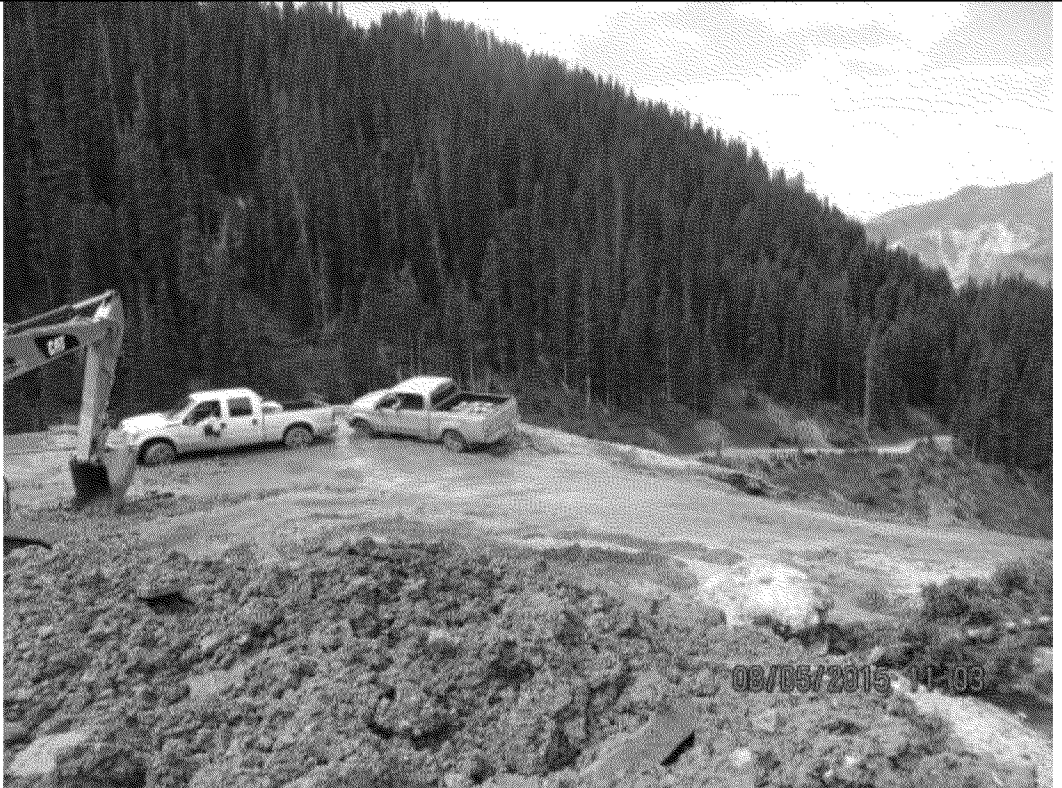
<b>Photo No.</b> <b>23</b>	<b>Date:</b> 08/05/2015

<b>Direction Photo Taken:</b>  Southwest		
<b>Description:</b> Exit route starting to collapse		
<b>Photo No.</b> <b>24</b>	<b>Date:</b> 08/05/2015

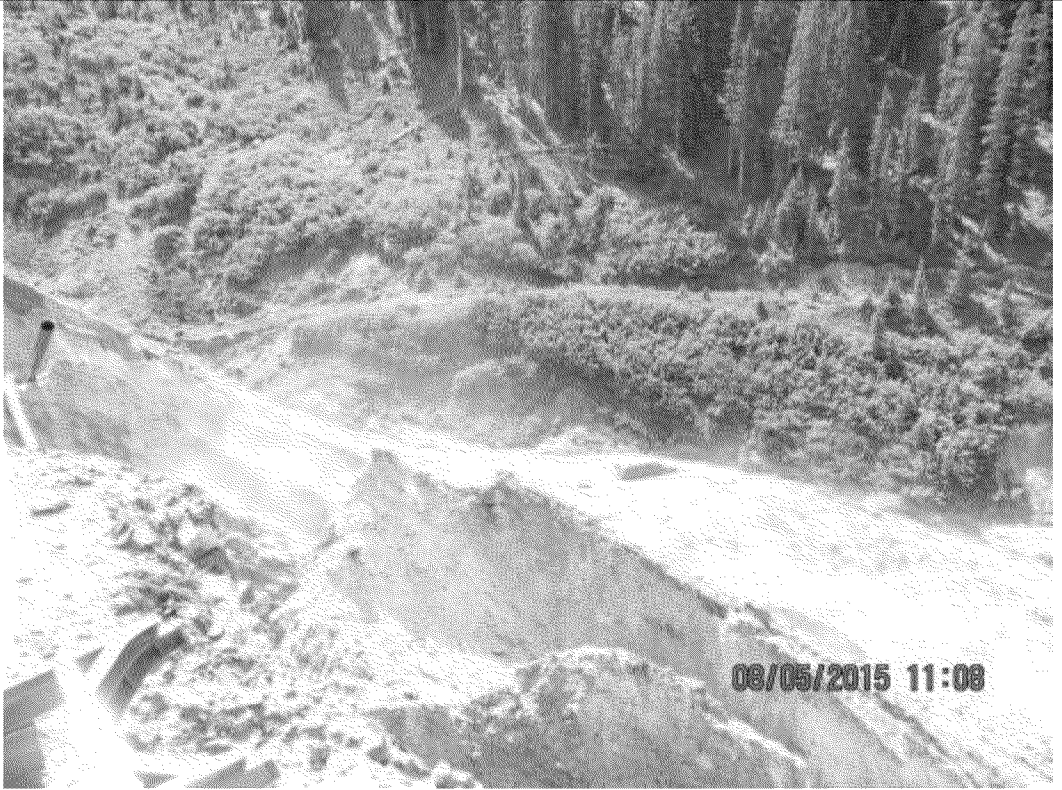
<b>Direction Photo Taken:</b>  Southeast/Down		
<b>Description:</b> Edge of the tailings dump collapsed, suburban trapped and half submerged in center of photo.

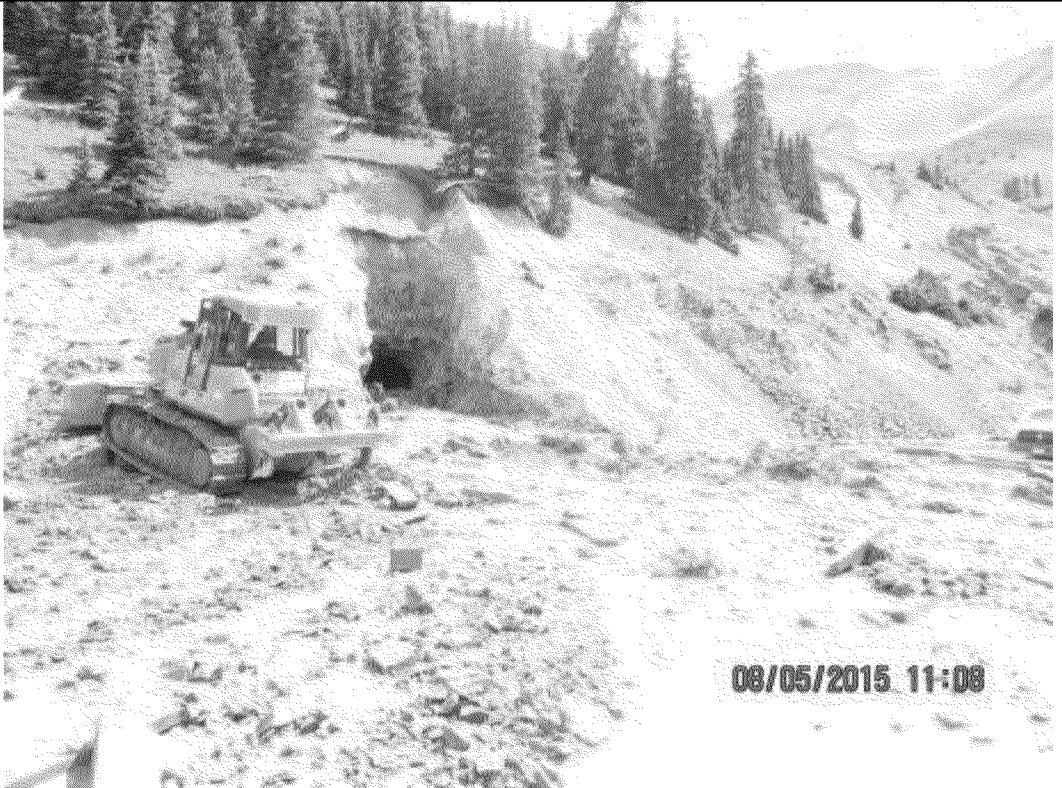
<b>Photo No.</b> <b>25</b>	<b>Date:</b> 08/05/2015

<b>Direction Photo Taken:</b>  Northeast		
<b>Description:</b> Gold King adit exposed.		
<b>Photo No.</b> <b>26</b>	<b>Date:</b> 08/05/2015

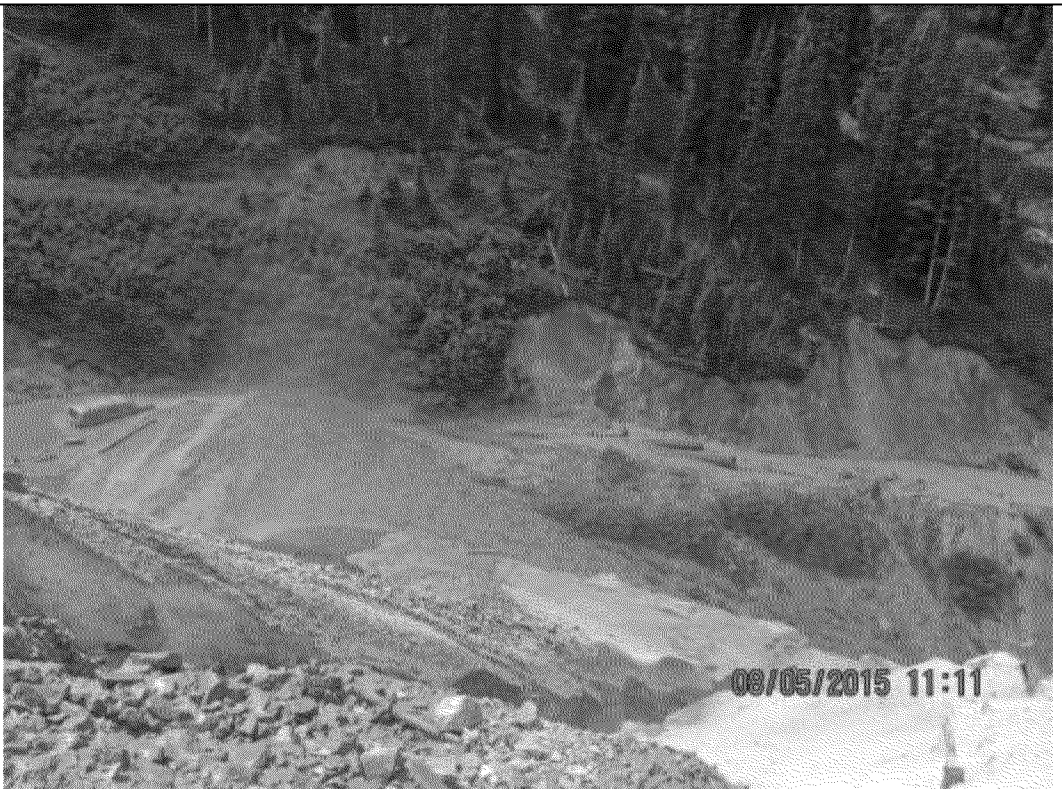
<b>Direction Photo Taken:</b>  Southeast		
<b>Description:</b> Water flow washing out the existing road. Note Suburban in left side of photo.

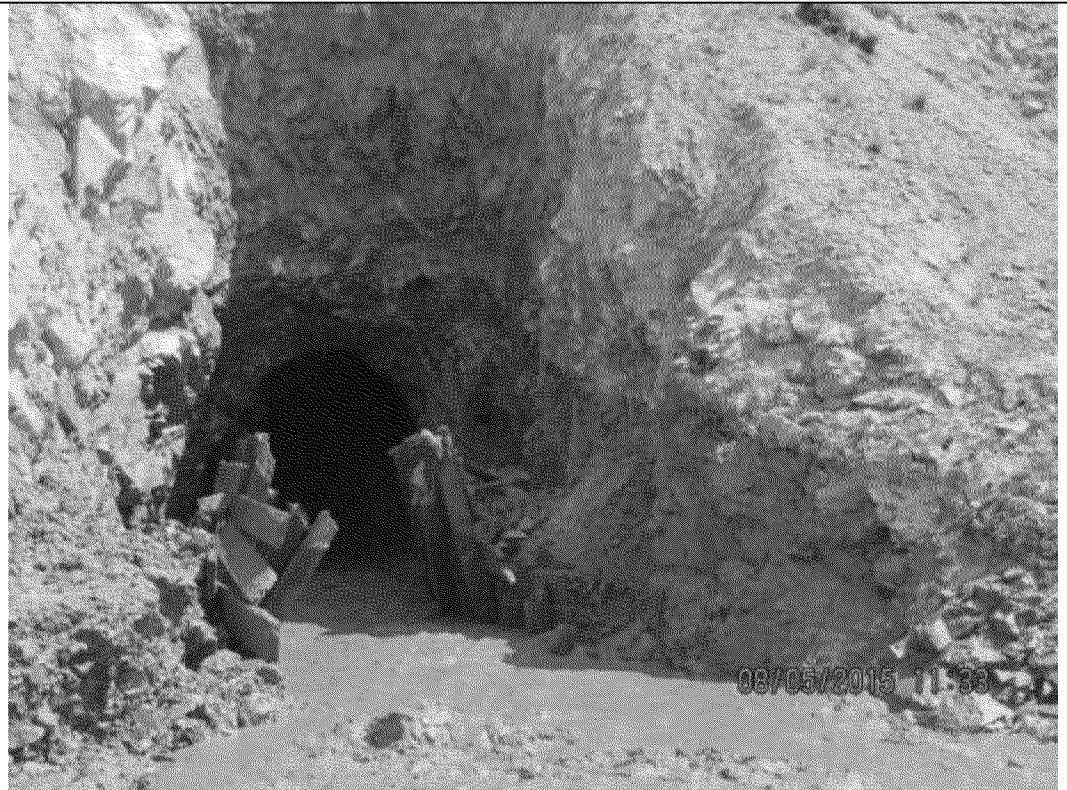
**Photo No.**  
**27**

Exposed adit, roughly 10 feet wide by 15 feet high.

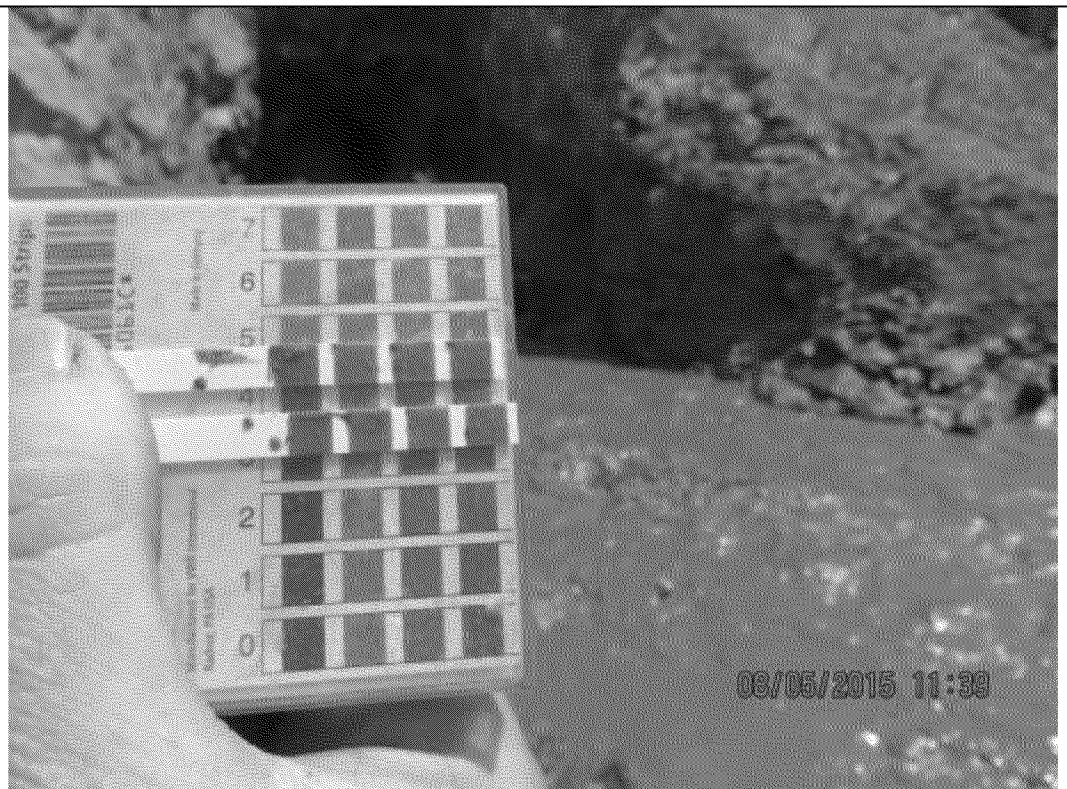
**Photo No.**  
**28**

pH of discharge water is approximately 4 to 4.5.

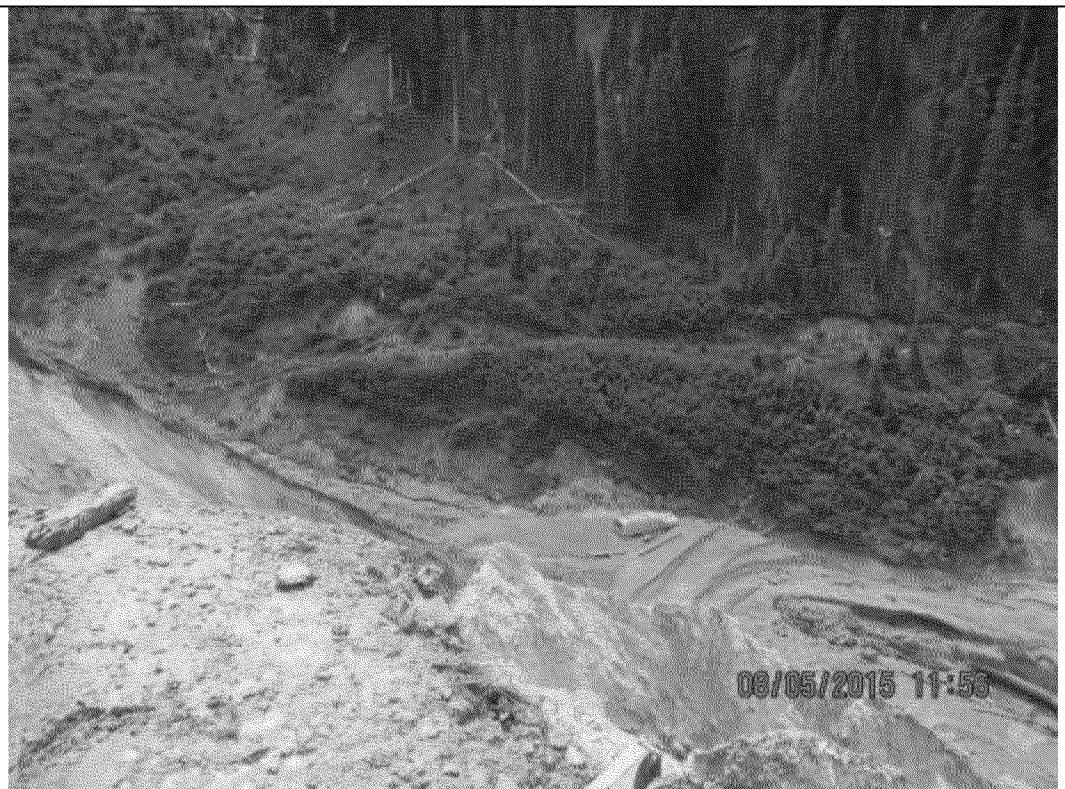
**Photo No.**  
**30**

Collapsed portion of waste dump and road wash out.

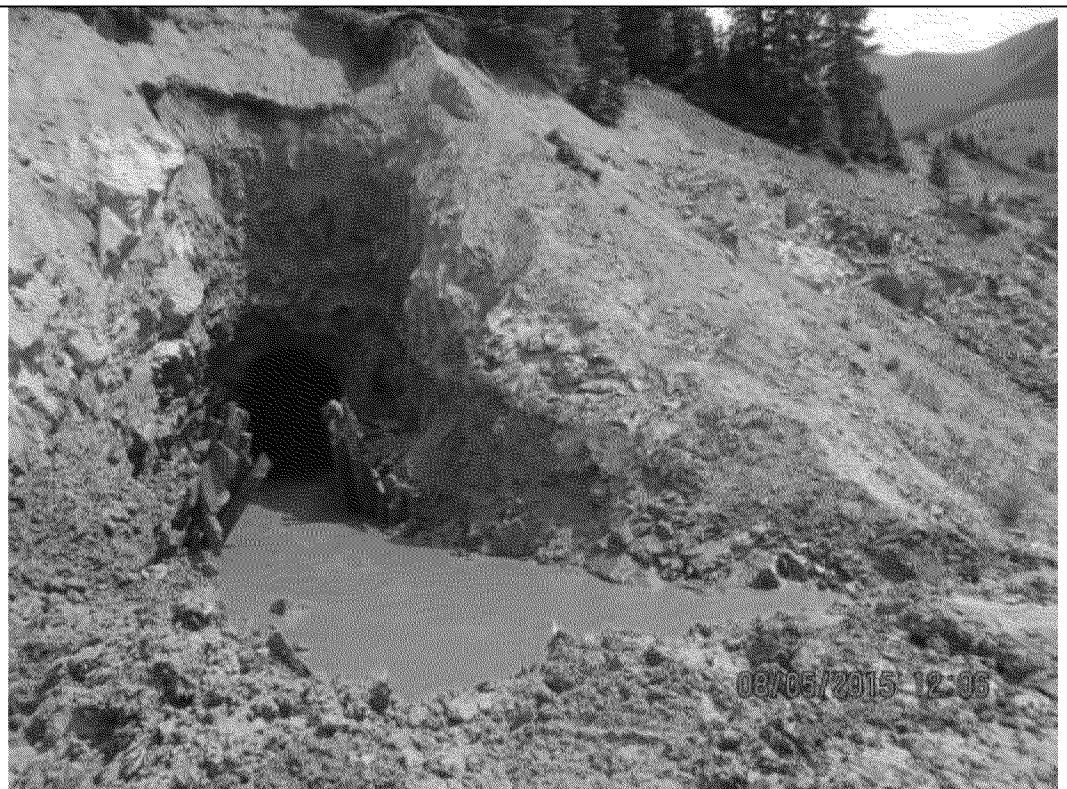
**Photo  
No.  
32**

Exposed adit and  
redirected flow, flow is  
beginning to subside.

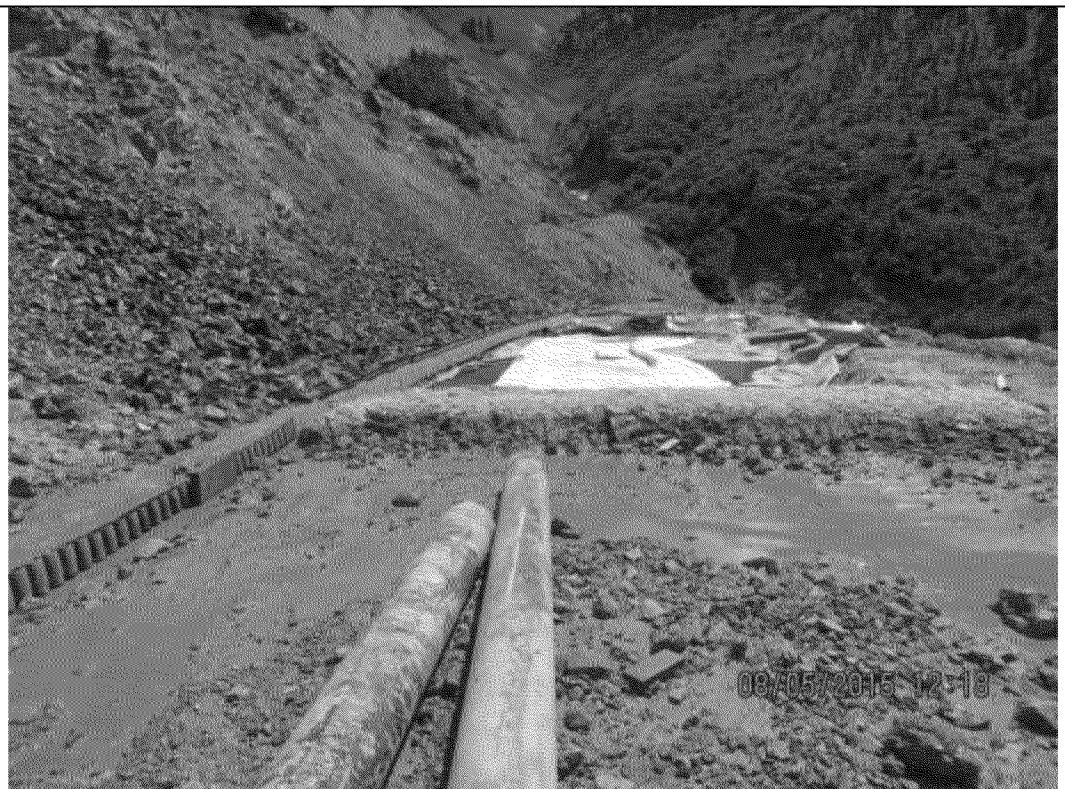
**Photo No.**  
**36**

Existing flow channel at maximum capacity.
